Lawrence Berkeley National Lab
Advanced Light Source
Experimental Systems Group
One Cyclotron Road
Berkeley CA 94720

BL 8.3.2 Theta-1 Stage Vibration Analysis

J Nasiatka
Thursday, April 3, 2014

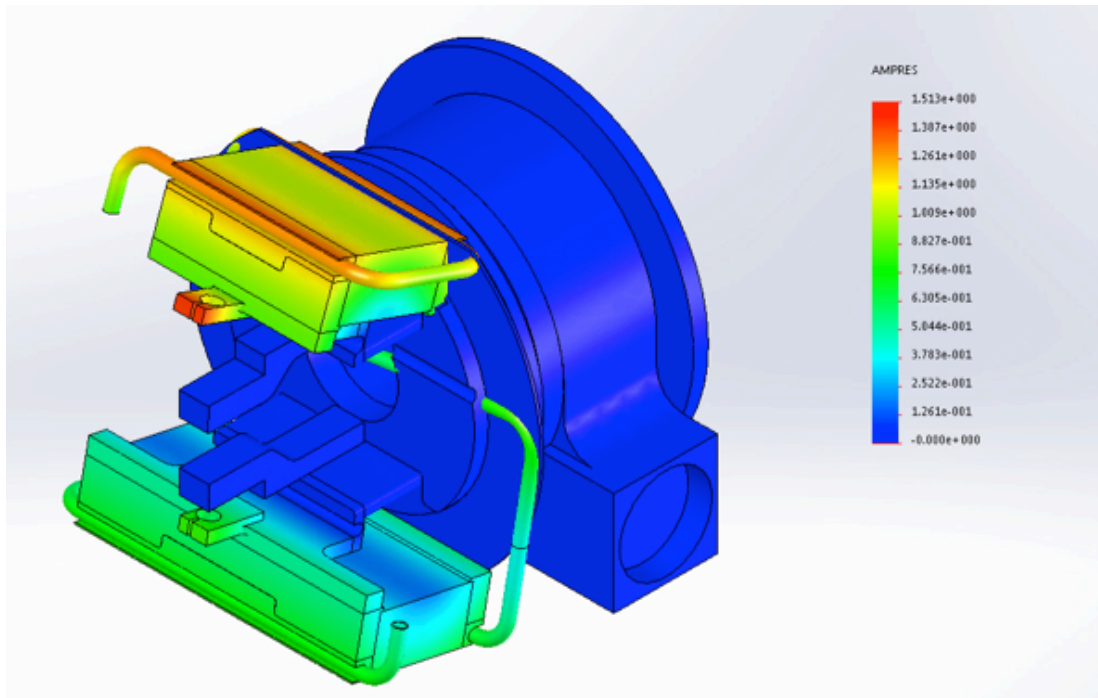
Mode 1 - 77Hz

Removing the roll adjustment screws and allowing the optics to float freely at the outboard end significantly reduces the lower order modal harmonics to under 100Hz and show that the optics would bounce. 3rd order and above are all higher than 200Hz and out of the problem area.

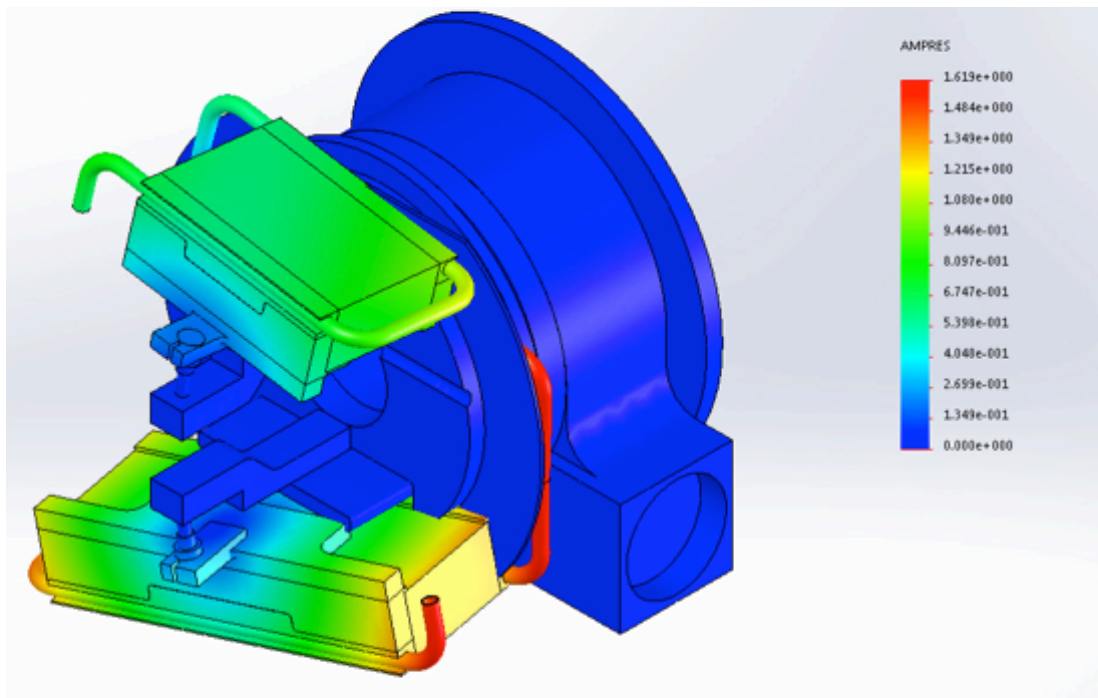
Mode 5 - 75Hz

Completely removing the flexures from the optical assemblies is not a real world possibility as the adjuster screws have ball ends and everything would fall off, however, it does show what would happen if the flexures completely failed.

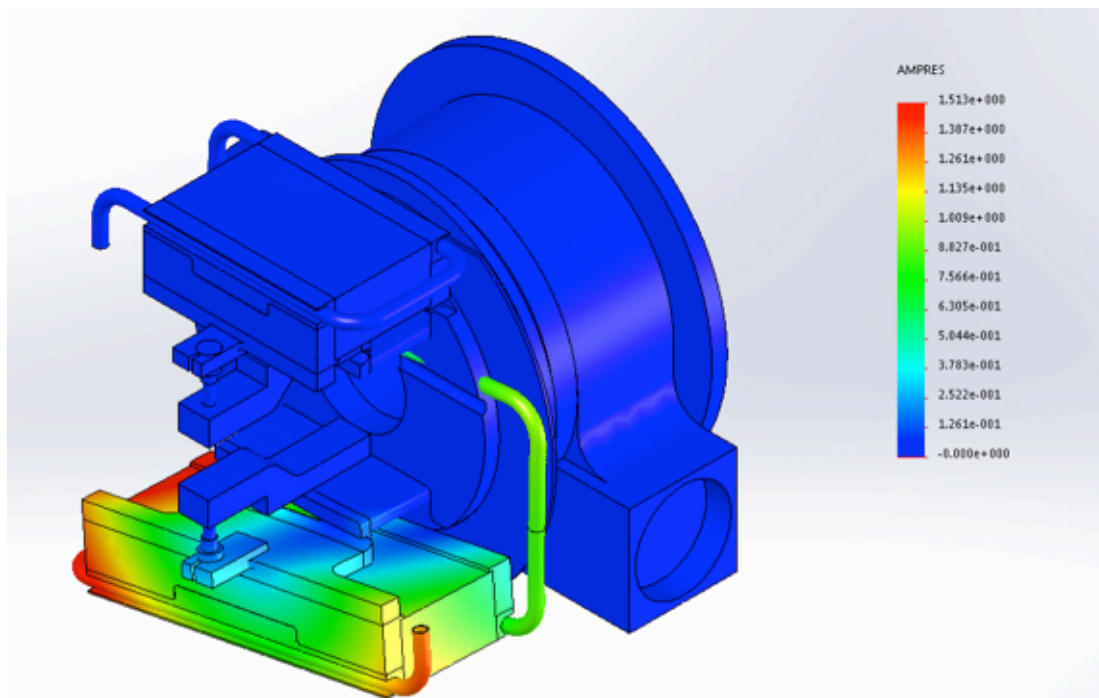
Mode 1 - 120Hz

At some point during user operations the monochromator turrets collided damaging the flexure on the multilayer. Due to time constraints, the assembly was patched, but a replacement flexure was never installed. To simulate the damaged flexure, a section of it was cut away. The first and second modes are within the region of vibration from the water lines

Replacing the damaged flexures on the optical assembly will stiffen the system and increase the harmonic modes to above 200 Hz. It will also reduce the influence of the water hammer induced vibrations by 60-65%

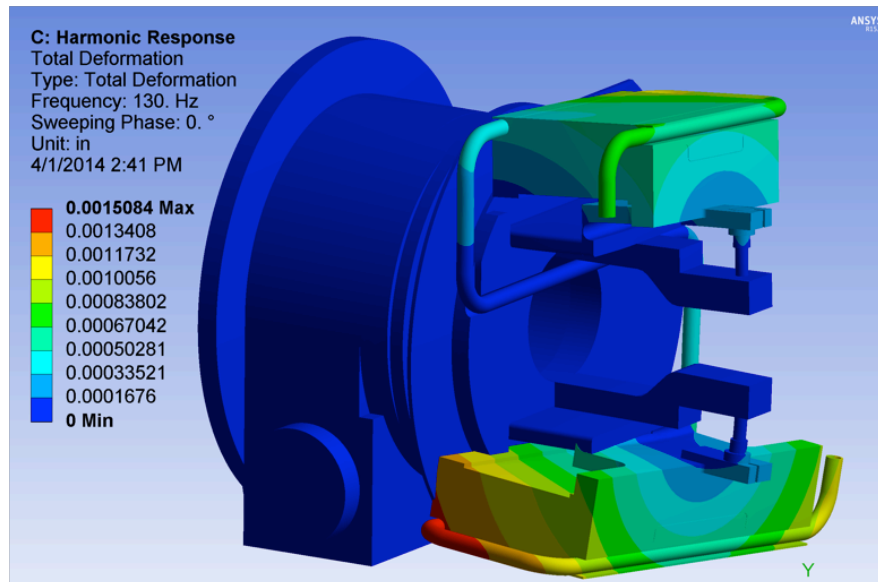
Damaged Flexure, 130Hz Water Hammer

130 Hz	165 Hz
Damaged Flexures	0.00151	0.00122
Undamaged Flexures	0.00046	0.00049
Coupled Adjuster Mounting	0.00033	0.00035
