Lawrence Berkeley National Lab
Advanced Light Source
Experimental Systems Group
One Cyclotron Road
Berkeley CA 94720

BL 8.3.2 Theta-1 Stage Vibration Analysis

J Nasiatka
Thursday, April 3, 2014

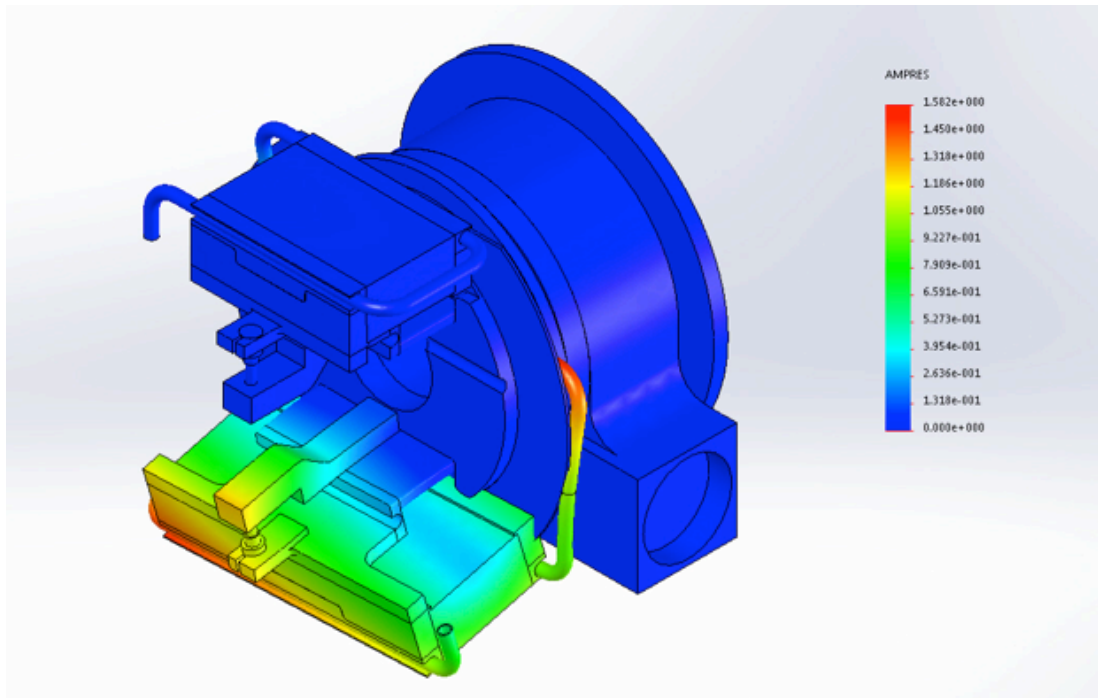
Mode 2 - 250Hz

The Multi-layer assembly, Si Xtal assembly, and the cooling lines connecting them all resonated at different frequencies. The table below shows the resonance and general sections of Theta-1 that were affected by them.

Mode	Frequency (Hz)	Section Affected
1	226 Hz	Cooling Lines and Multilayer
2	250 Hz	Multilayer and Cooling Lines
3	260 Hz	Multilayer and Cooling Lines
4	285 Hz	Cooling Lines
5	300 Hz	Si Xtal
6	350 Hz	Cooling Lines
7	410 Hz	Multilayer and Cooling Lines
8	430 Hz	Si Xtal
9	515 Hz	Multilayer and Xtal
10	520 Hz	Multilayer and Xtal

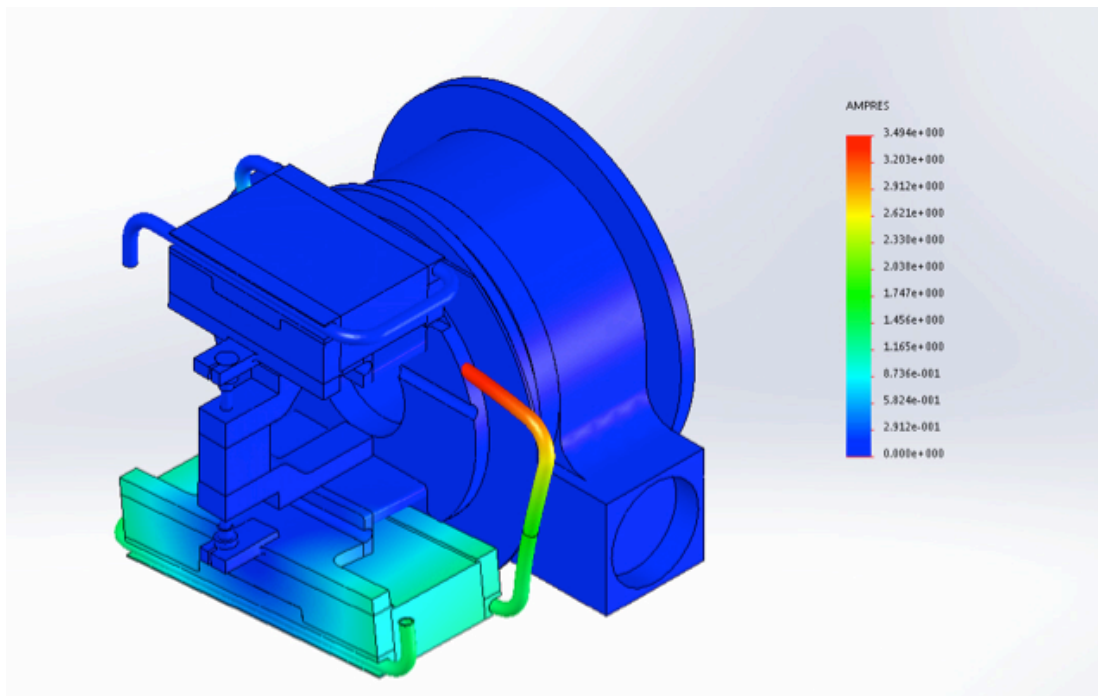
Mode 2 - 275Hz

Each optical assembly is currently independently mounted, and each resulting cantilever is free to flex. This simulation looks at how much stiffer the assembly would get by adding in a coupling spacer between the two and joining them together.

Mode	Frequency (Hz)	Section Affected
1	225 Hz	Cooling Lines
2	275 Hz	Multilayer and Cooling Lines
3	285 Hz	Cooling Lines
4	350 Hz	Cooling Lines
5	410 Hz	Multilayer and Cooling Lines
6	460 Hz	Si Xtal and Cooling Lines
7	520 Hz	Si Xtal and Cooling Lines
8	531 Hz	Multilayer and Si Xtal
9	670 Hz	Cooling Lines
10	790 Hz	Multilayer and Si Xtal

Coupling the adjuster screw mounting blocks will additionally remove around another 10% of the vibrations. It will also increase the The first mode will increase to 275 Hz, and the higher orders will be above 400 Hz.
